Chesapeake Boulevard (between East Little Creek Rd & Fishermans Rd) Pedestrian & Drainage Preliminary Engineering Report

City of Norfolk, Virginia

Department of Public Works

Timmons Group

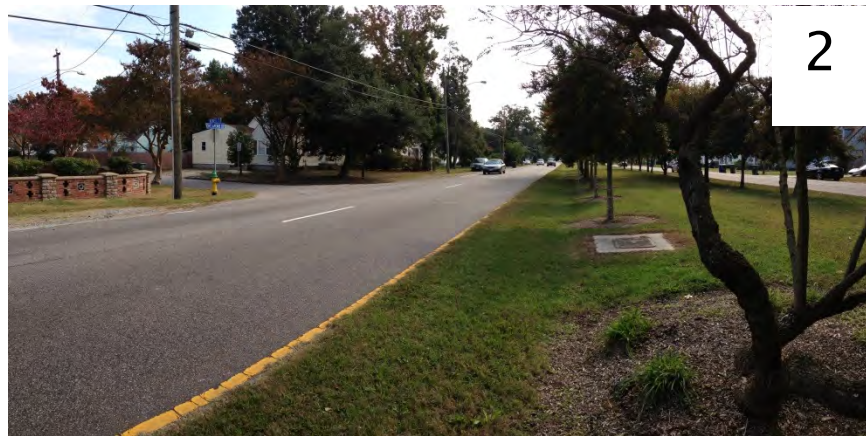
1

1. Facing east to intersection of Chesapeake Blvd and Fishermans Road (Panorama)
2. Facing west away at Bill Street Intersection
3. Facing south near Newell Street Intersection
4. Facing south away from Fishermans Road
5. Facing south at Tallwood Street Intersection
6. Facing south in center median
7. Facing north on west side of boulevard, just south of Vero Street Intersection

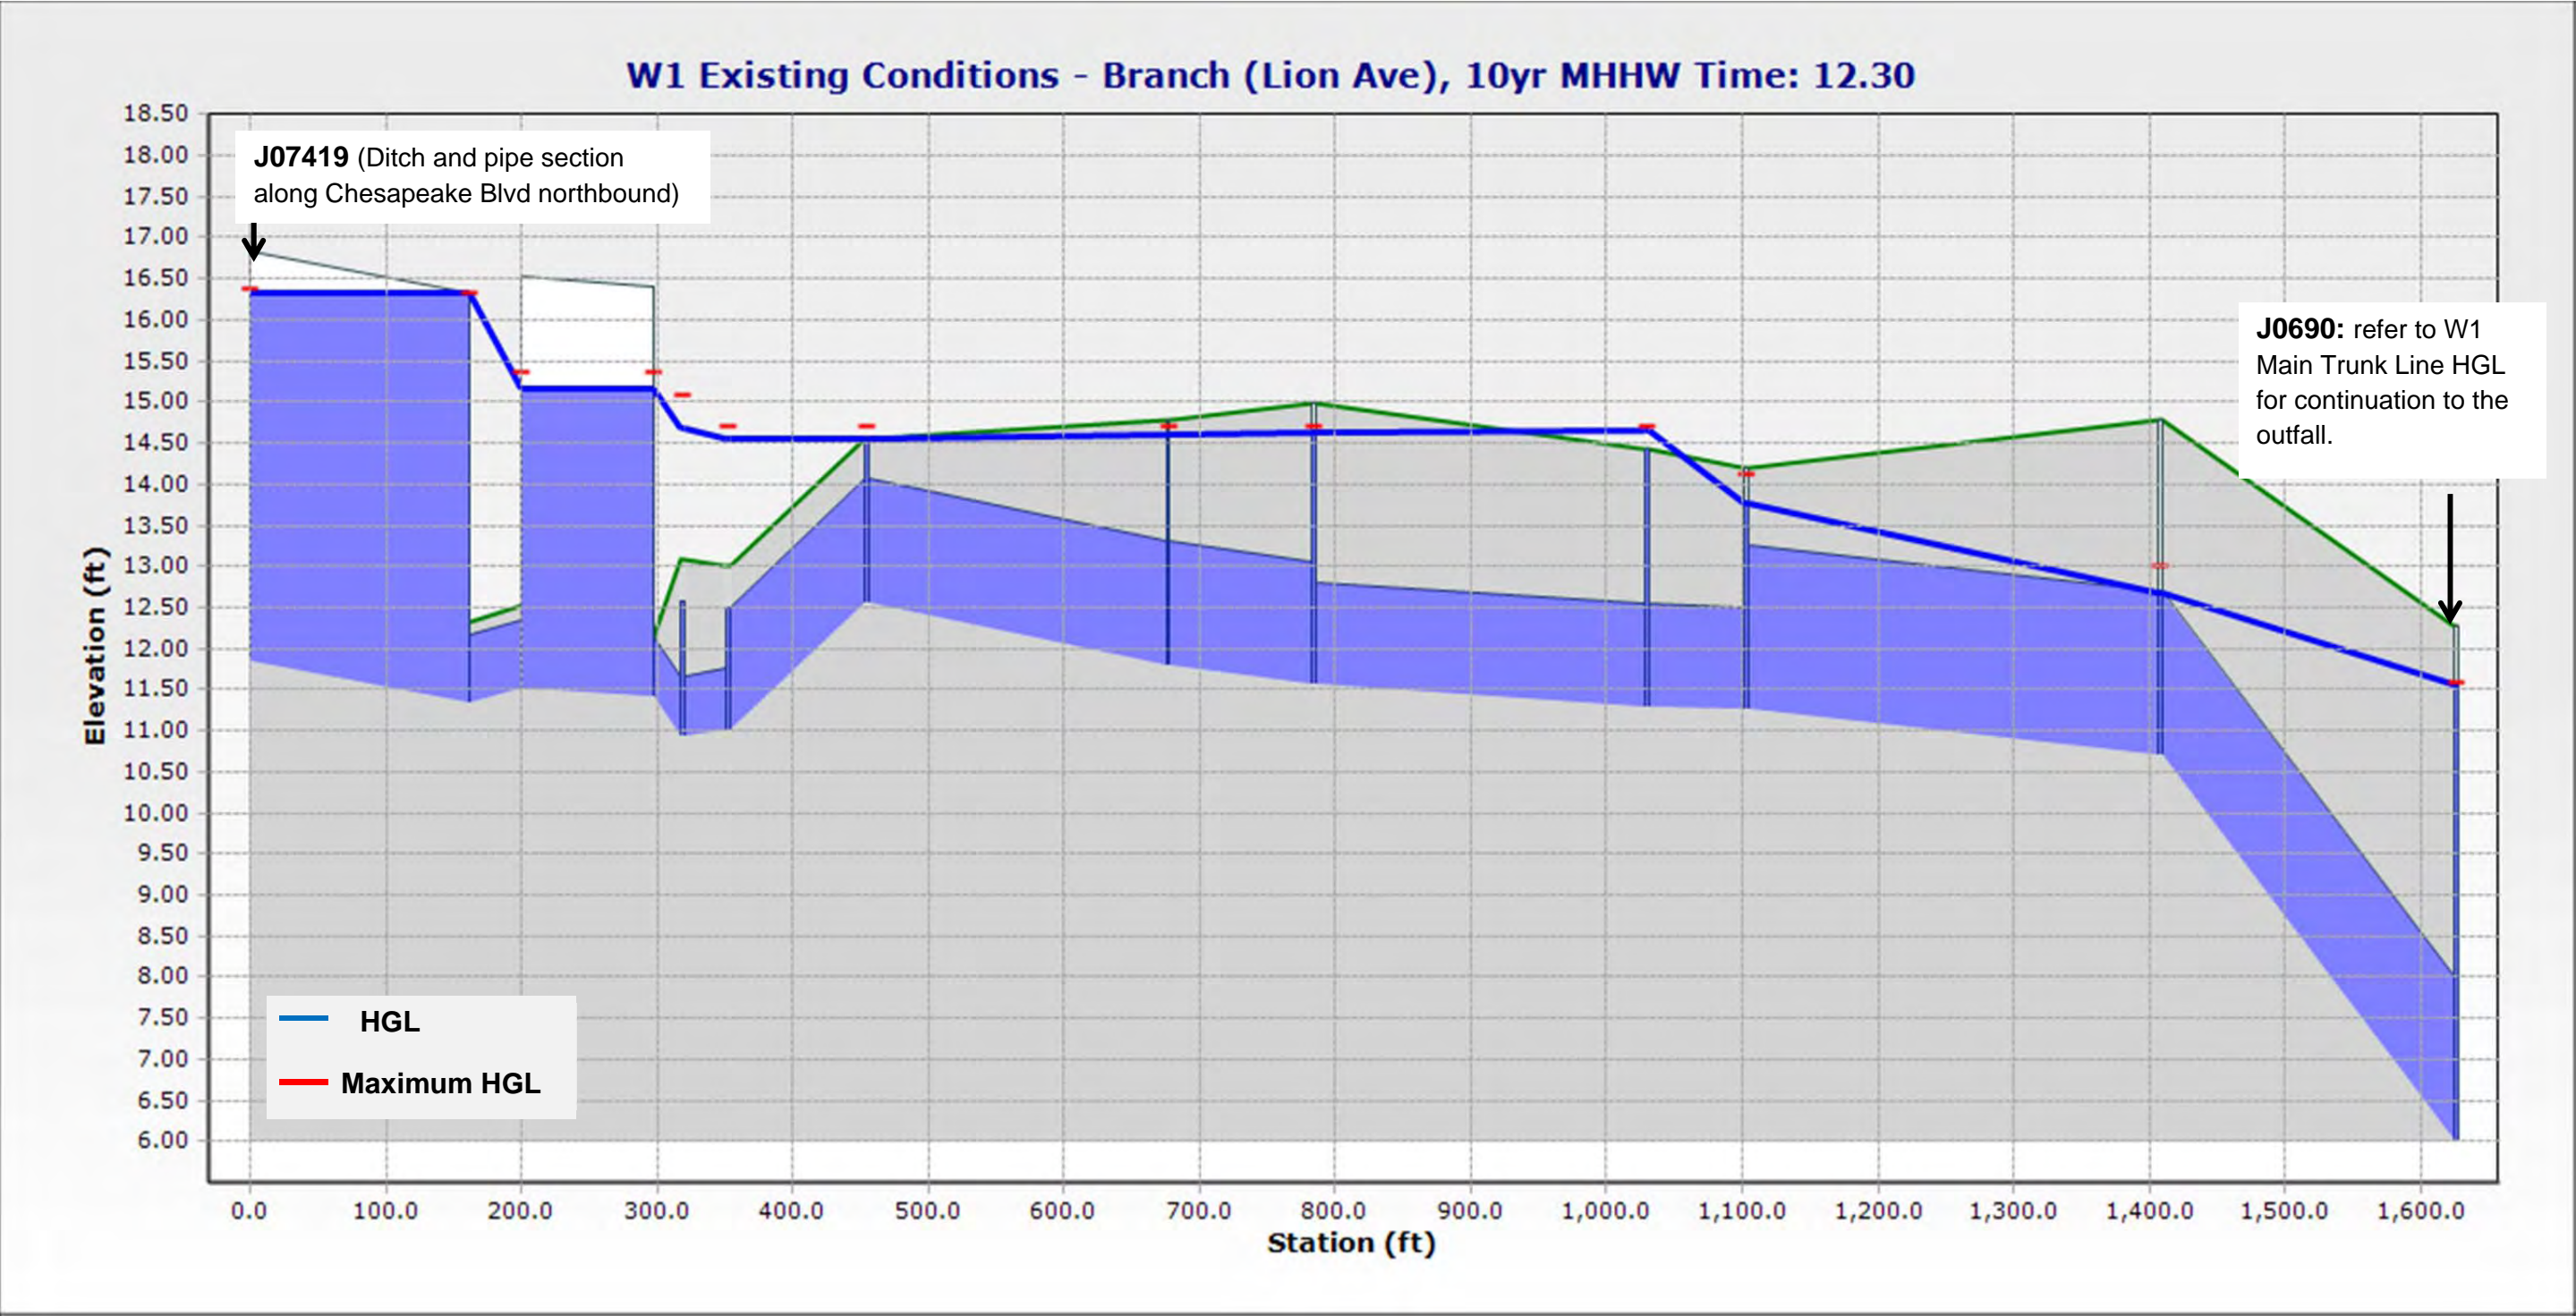
C.1. Sub-Watershed 1 - Existing Conditions along Lion Avenue Branch Section

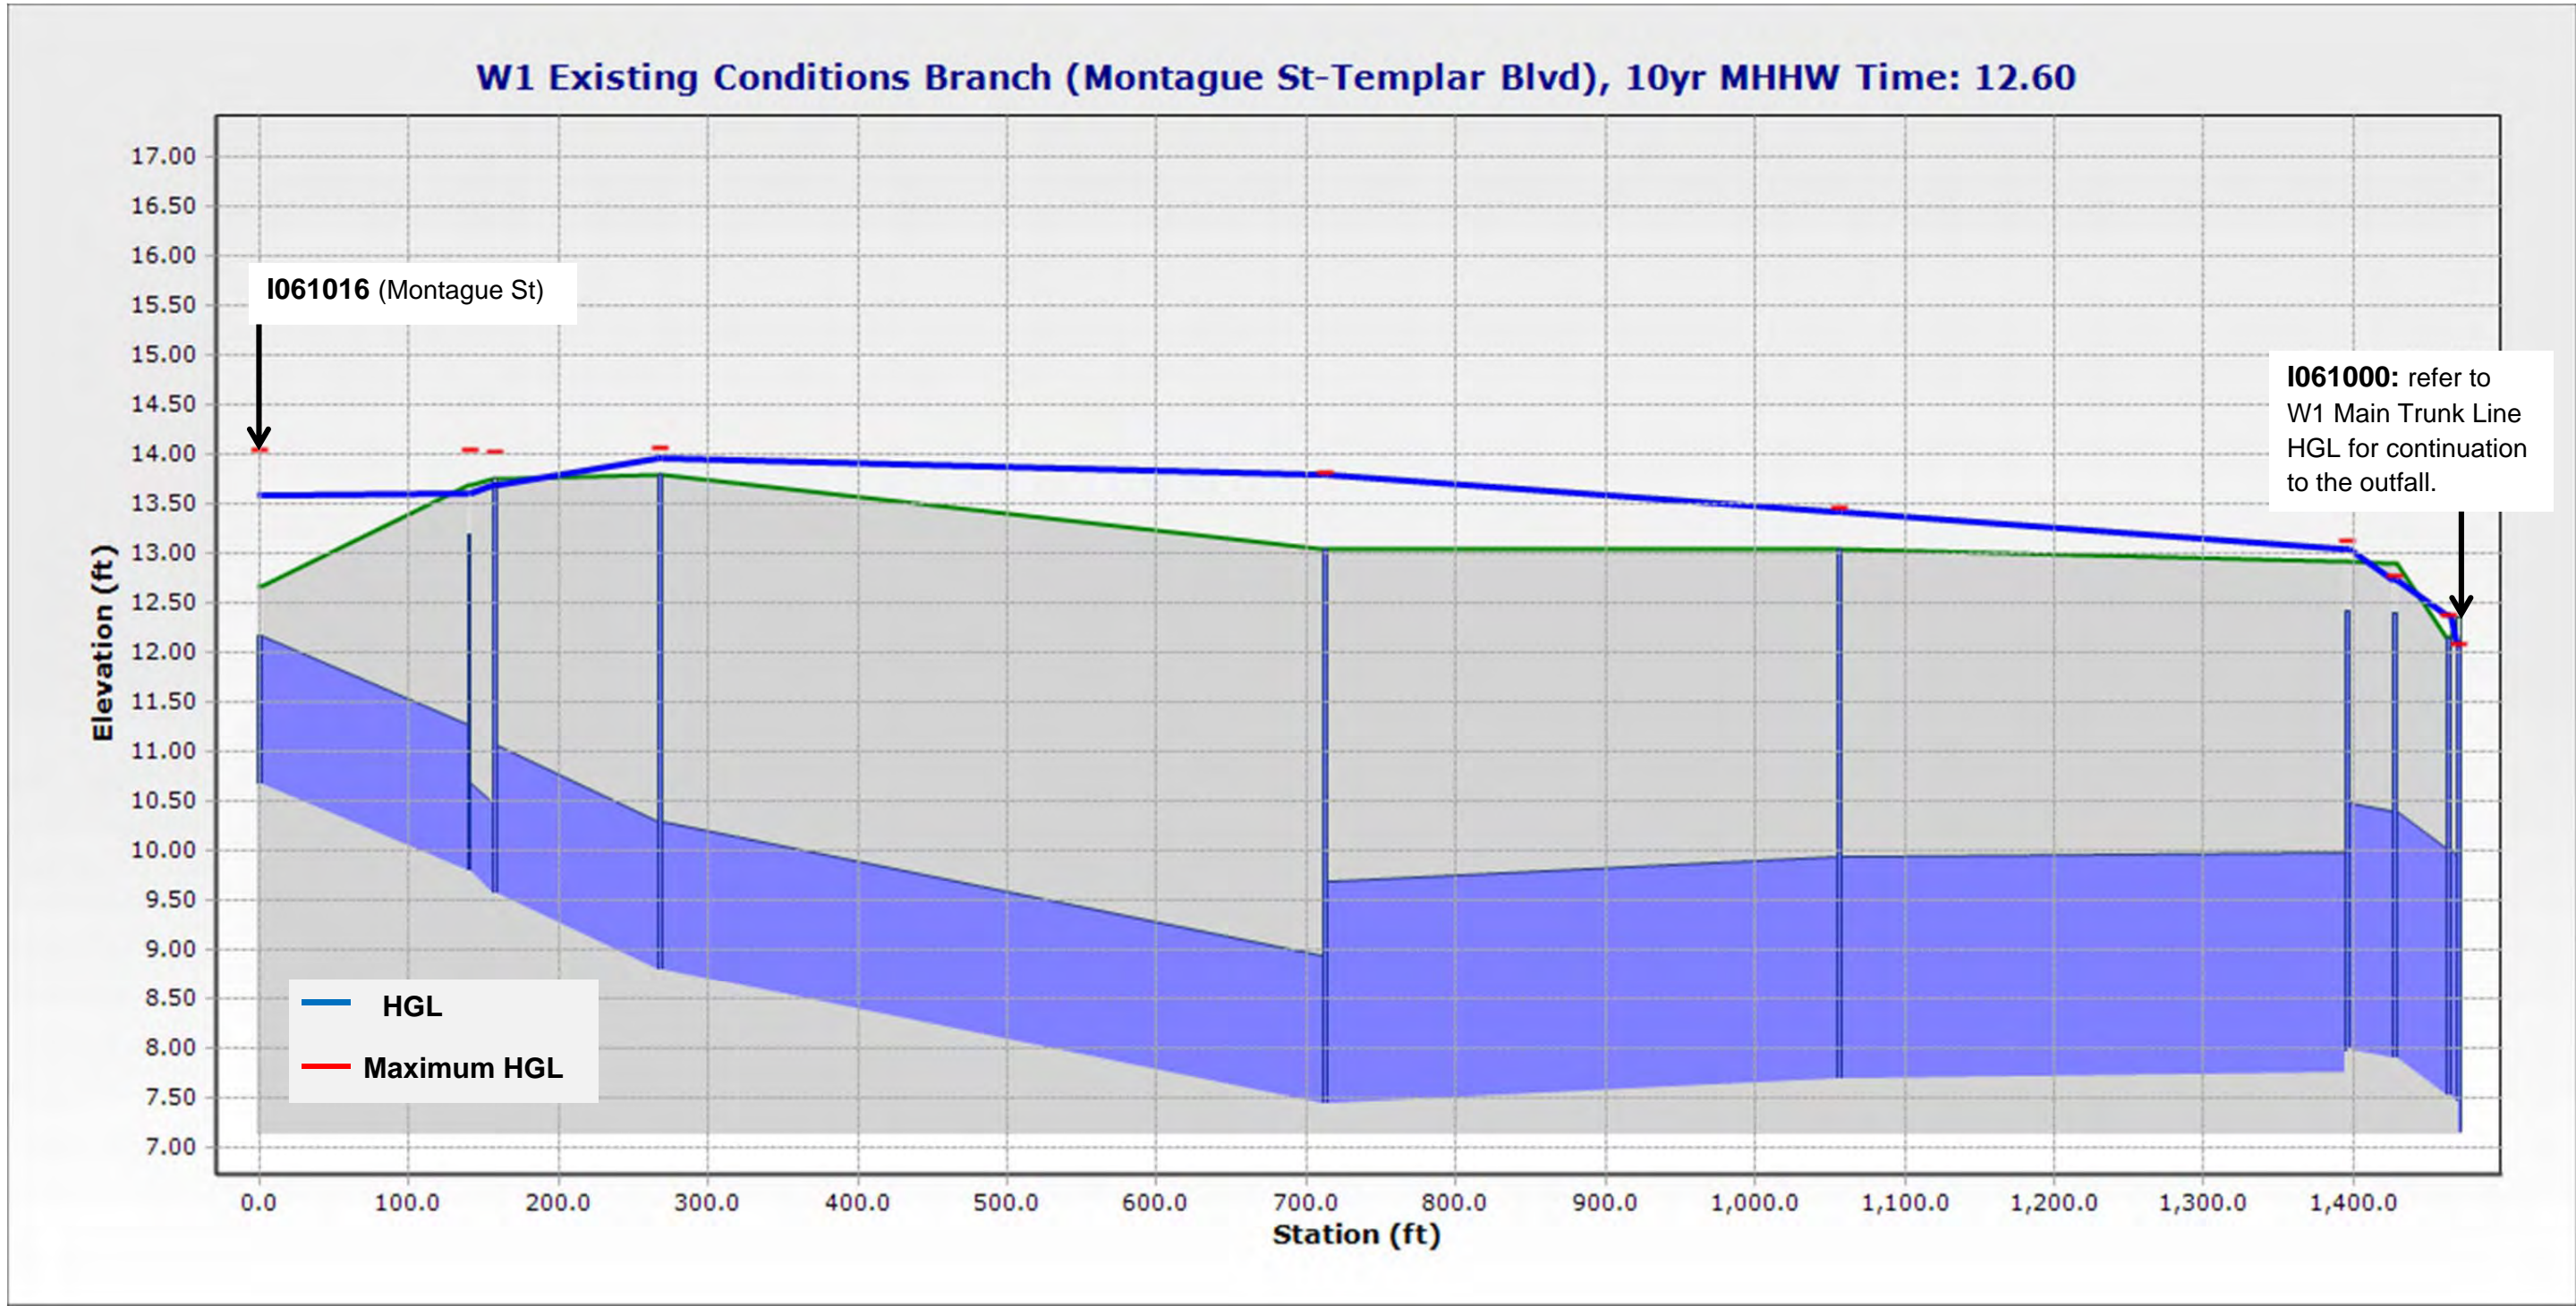
C.2. Sub-Watershed 1 - Existing Conditions along Branch Section between Montague Street and Templar Boulevard

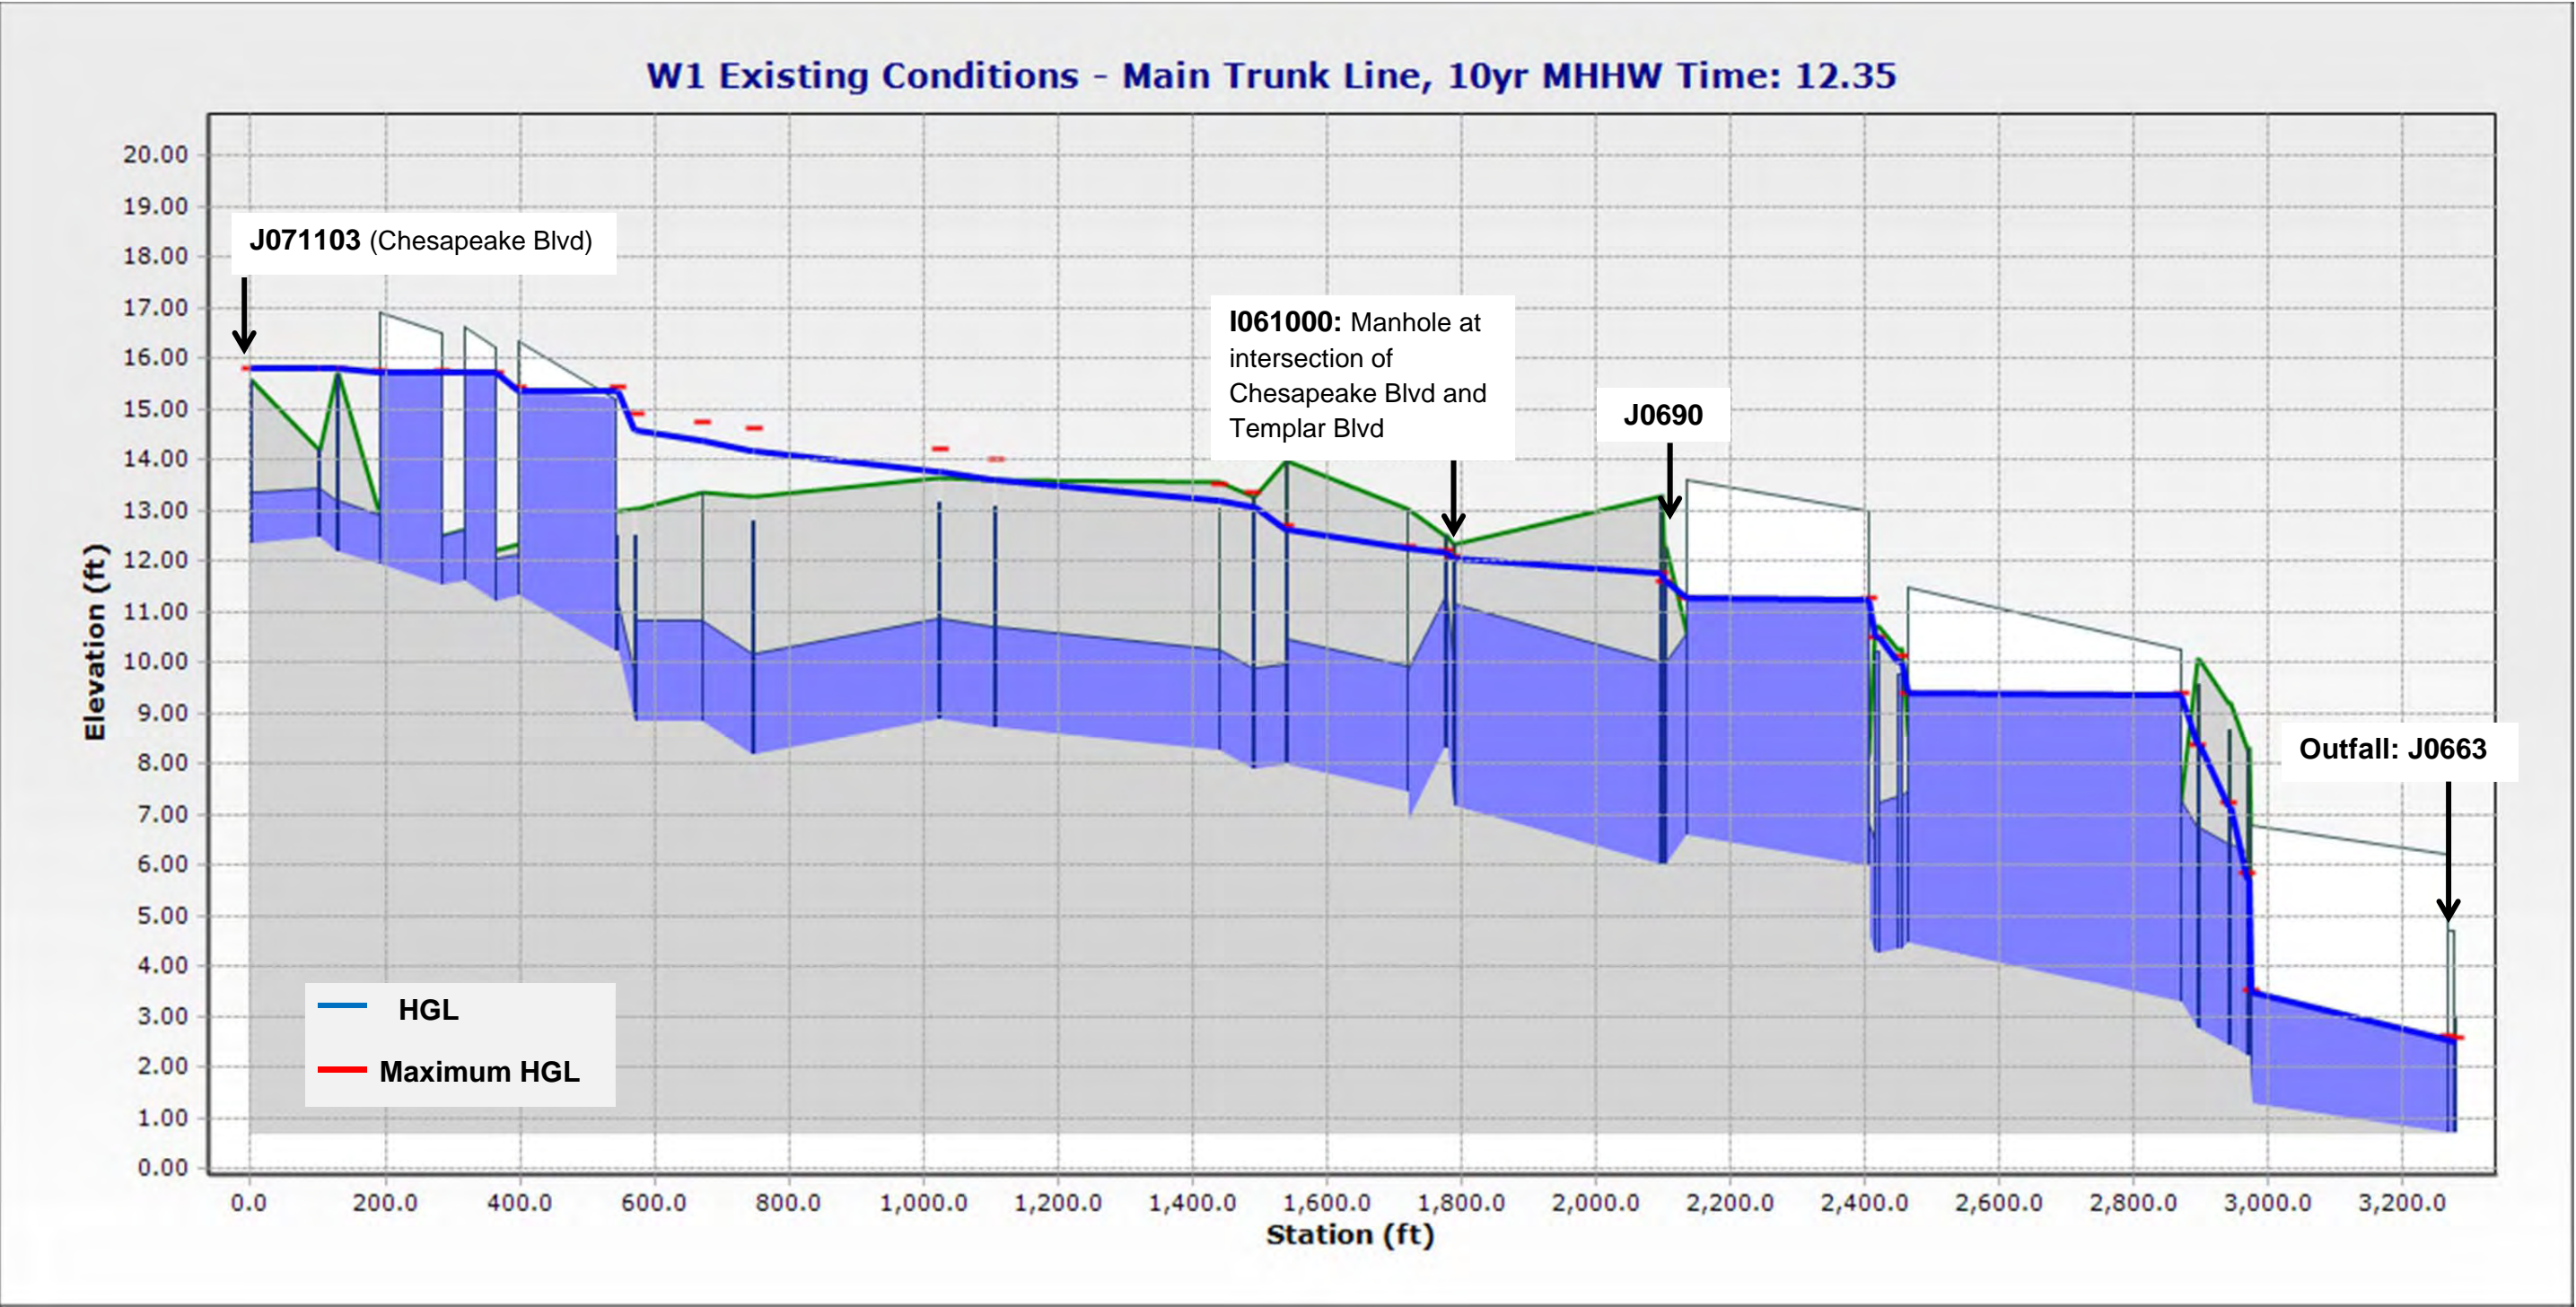
C.3. Sub-Watershed 1 - Existing Conditions along Main Trunk Line

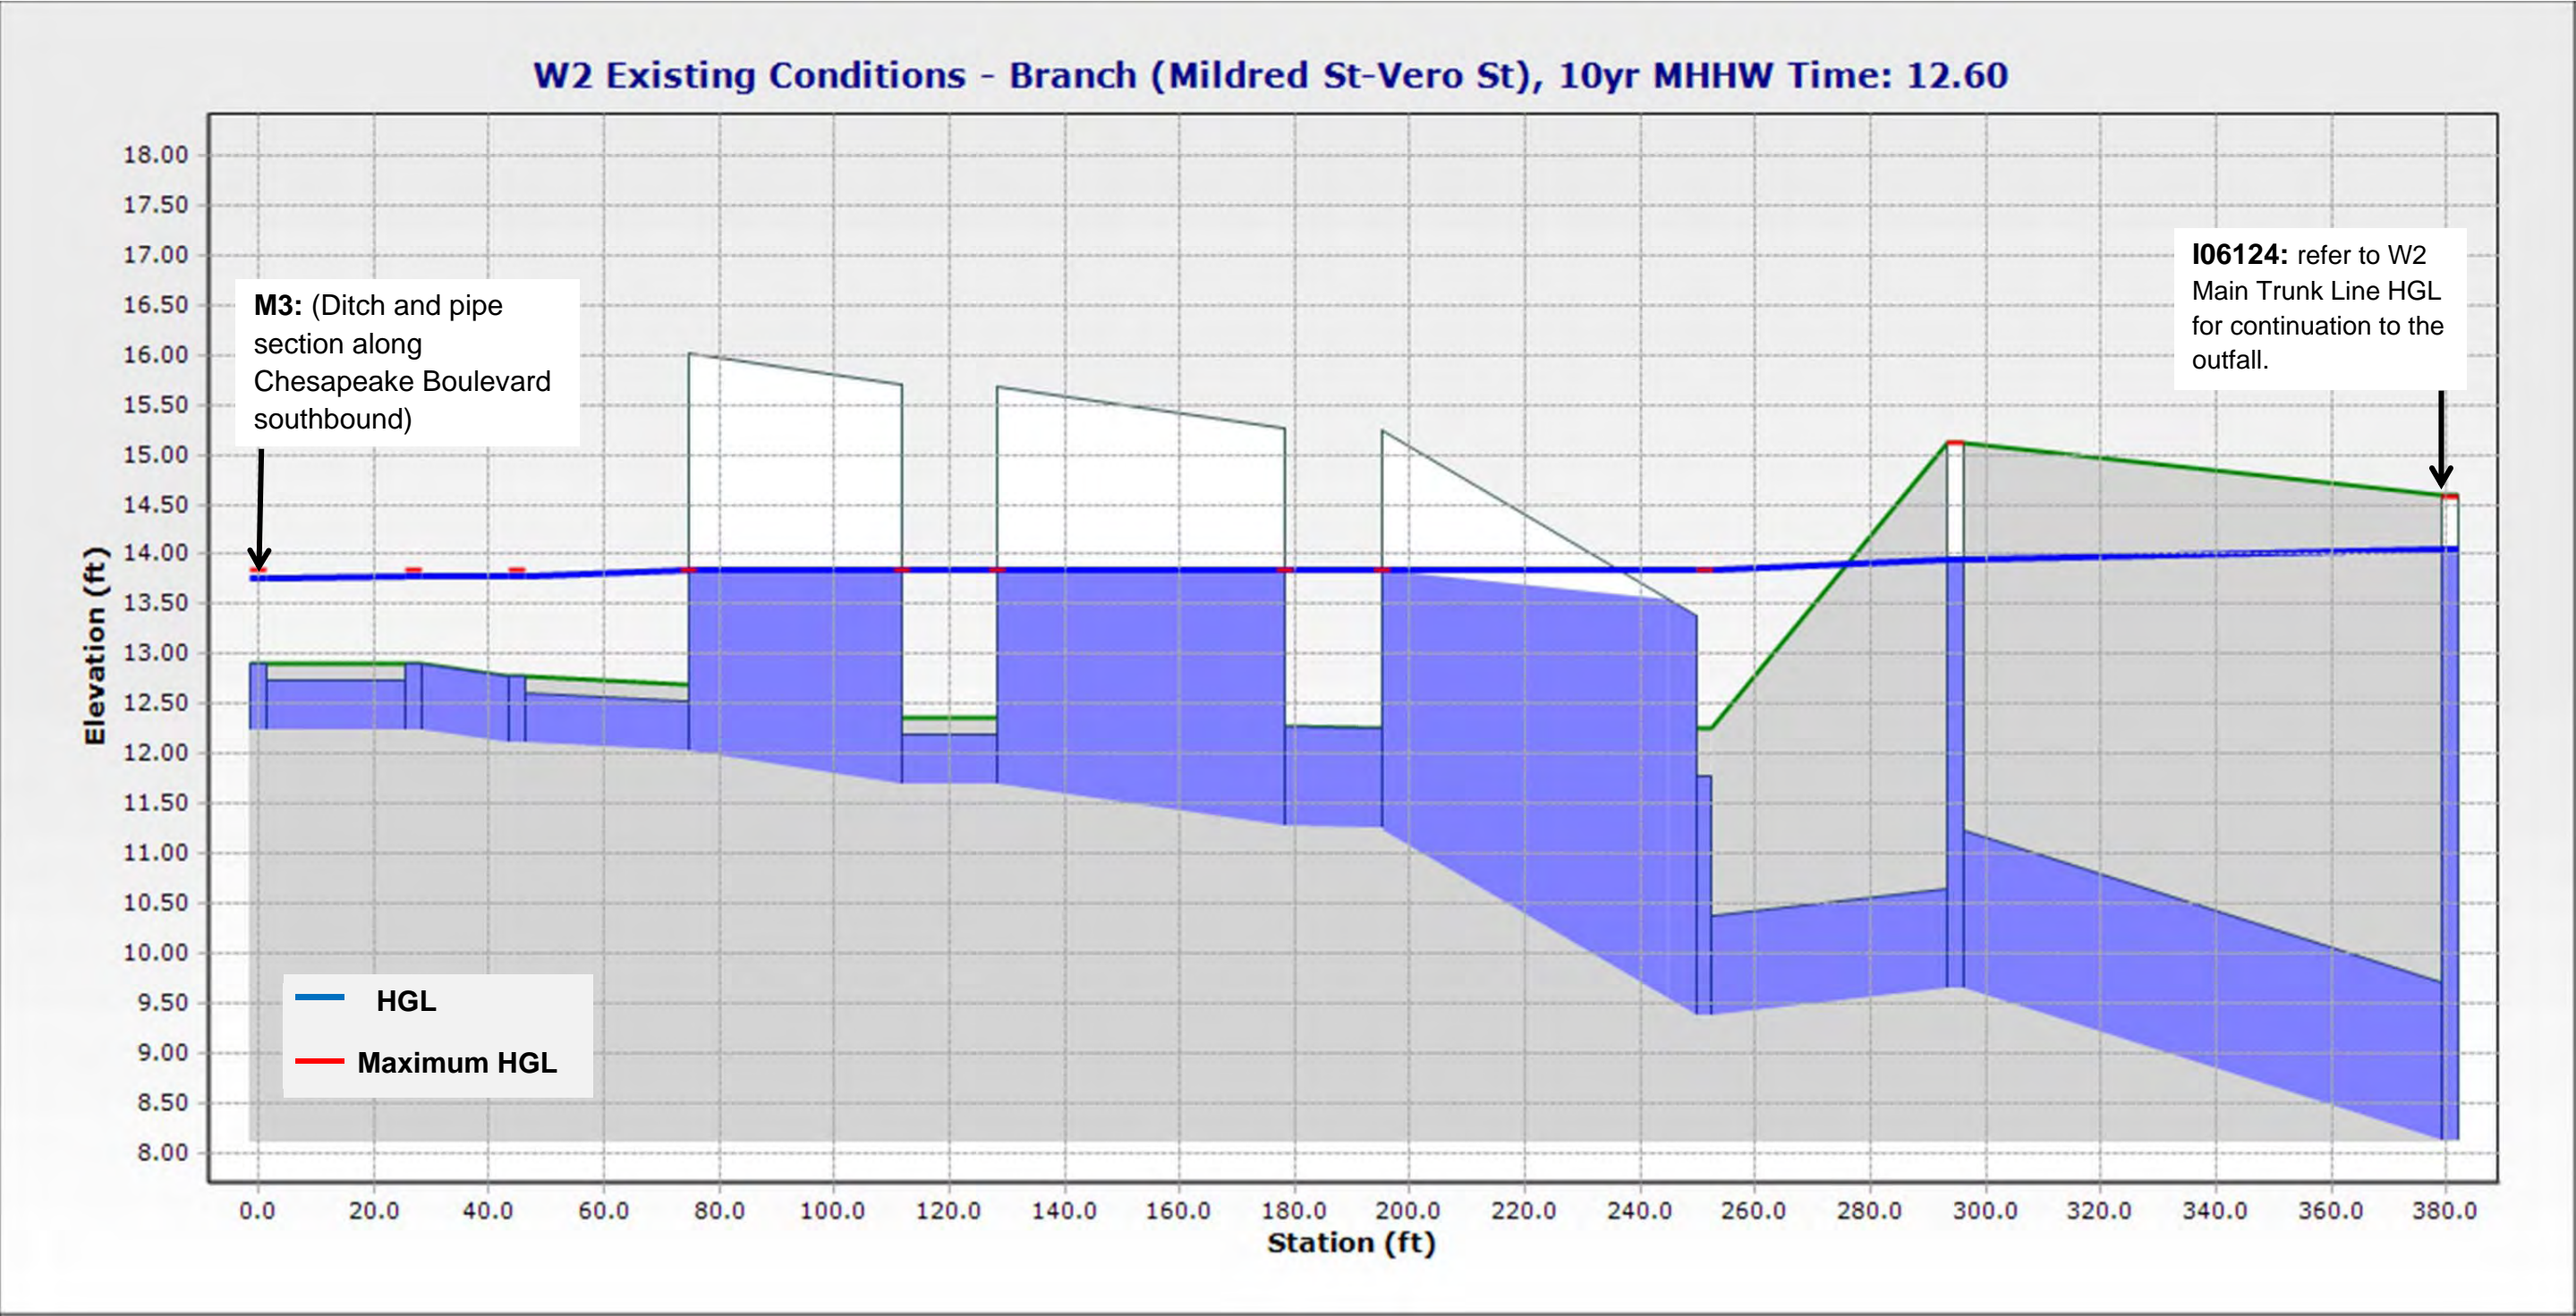
C.4. Sub-Watershed 2 - Existing Conditions along Branch Section between Mildred and Vero Streets

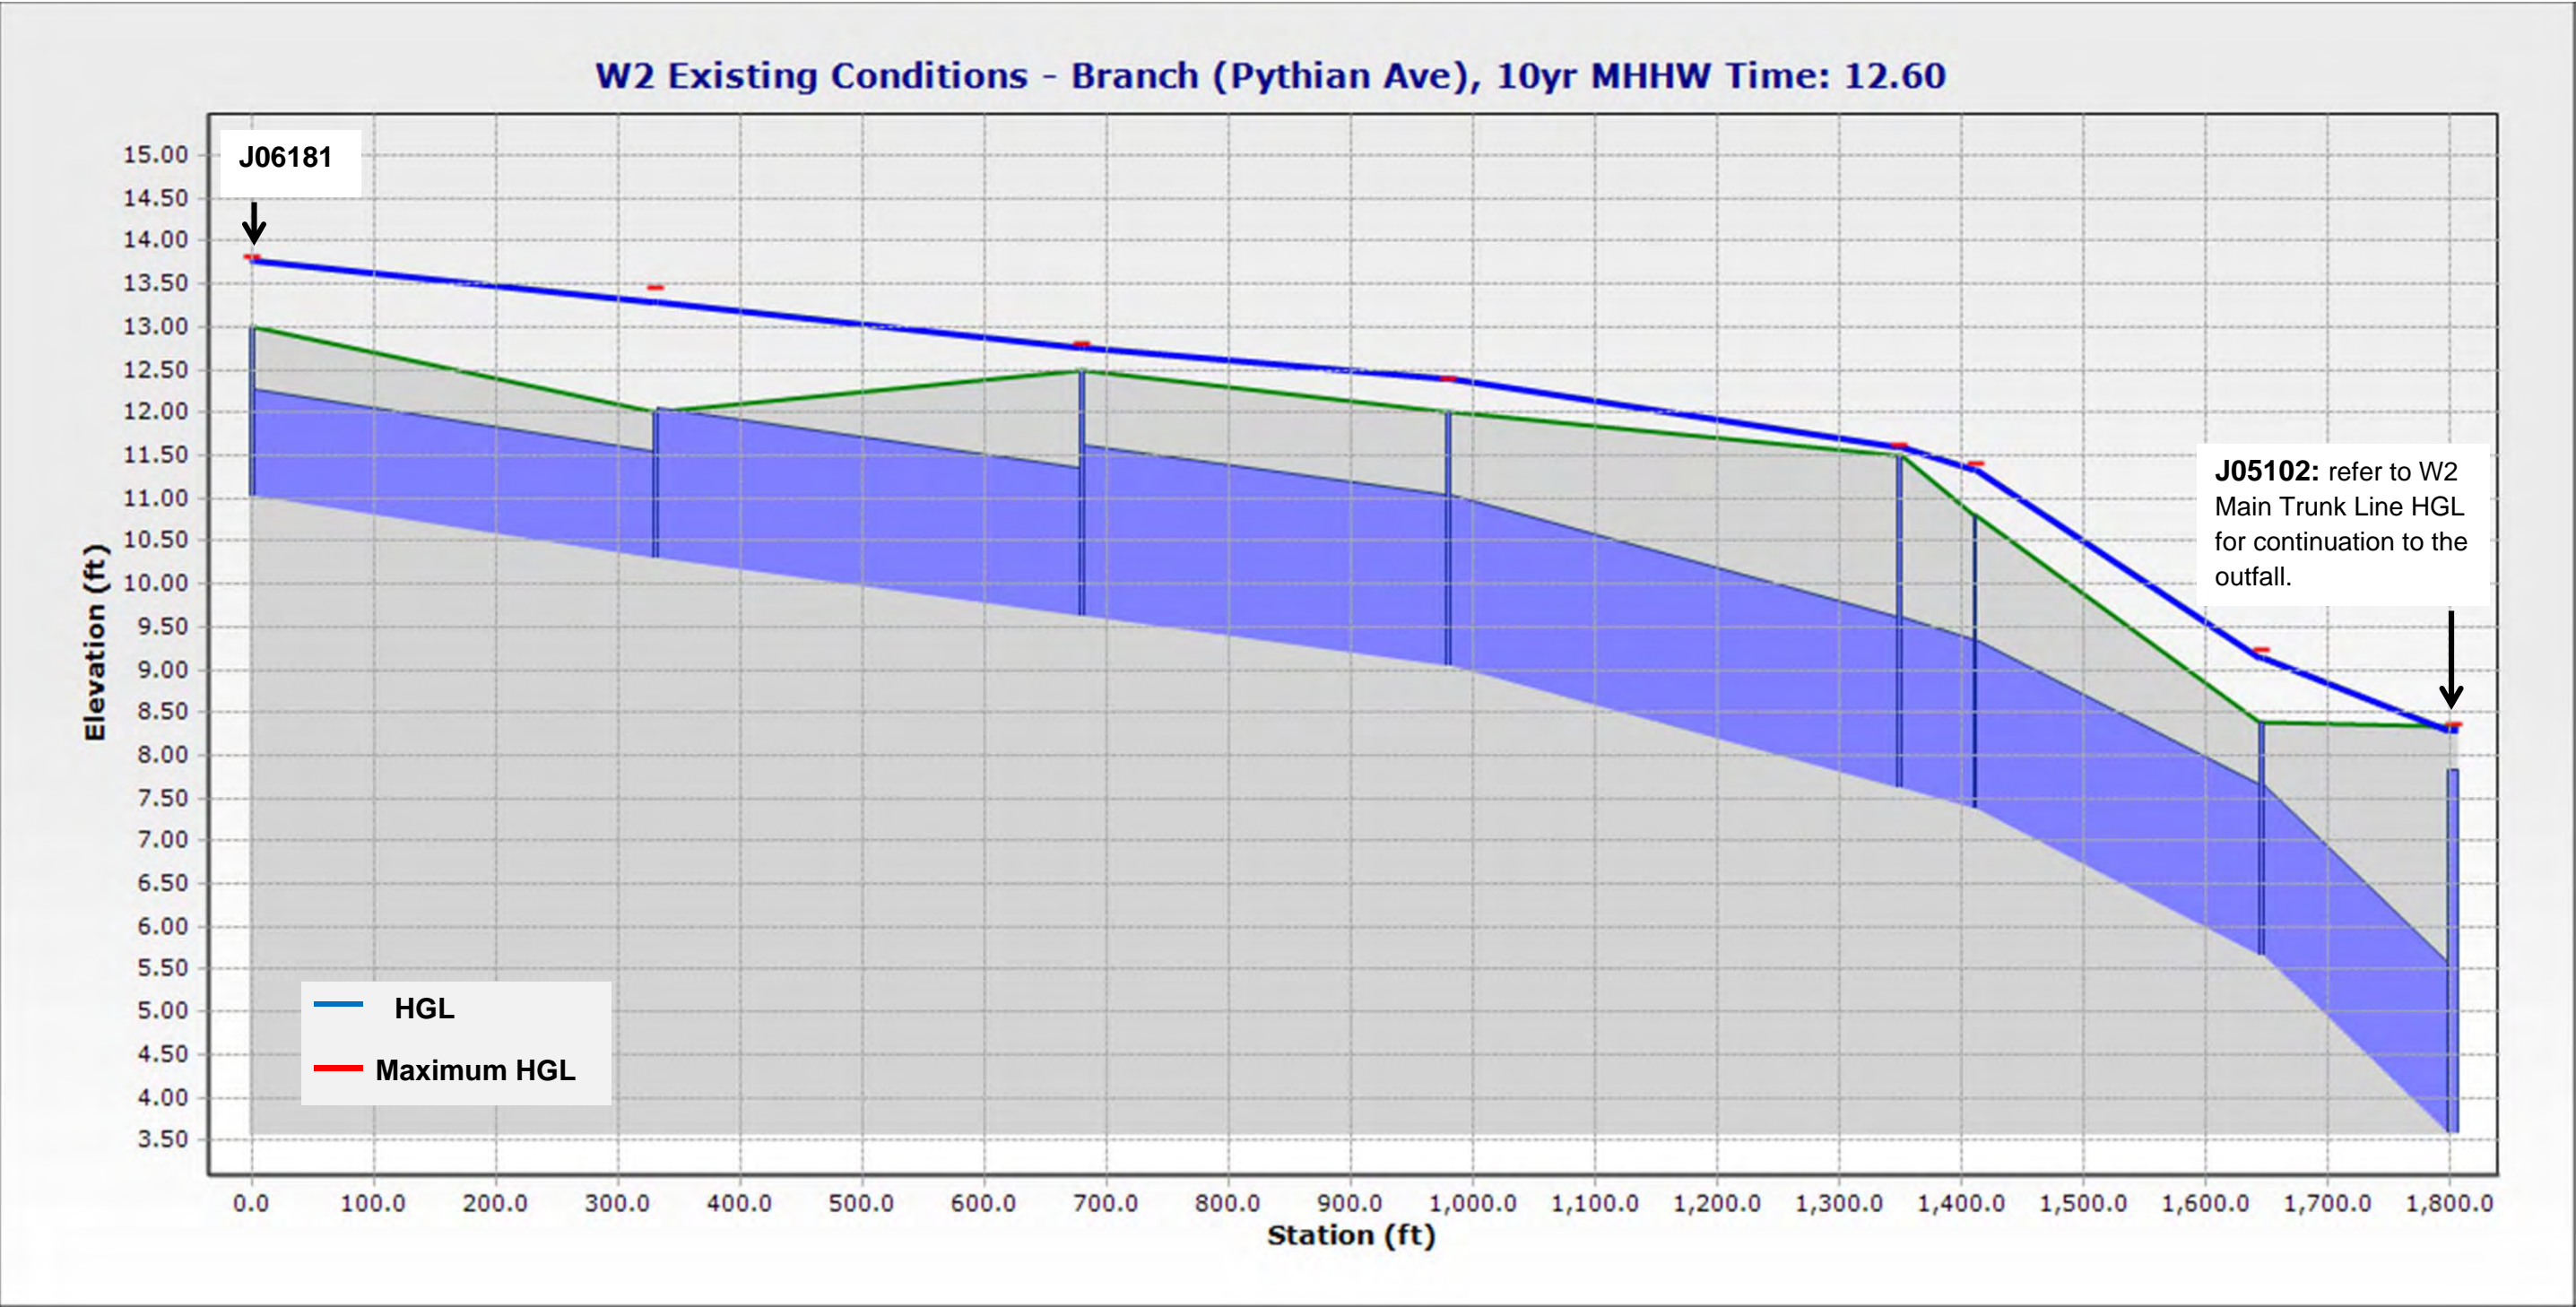
C.5. Sub-Watershed 2 - Existing Conditions along Pythian Avenue Branch Section

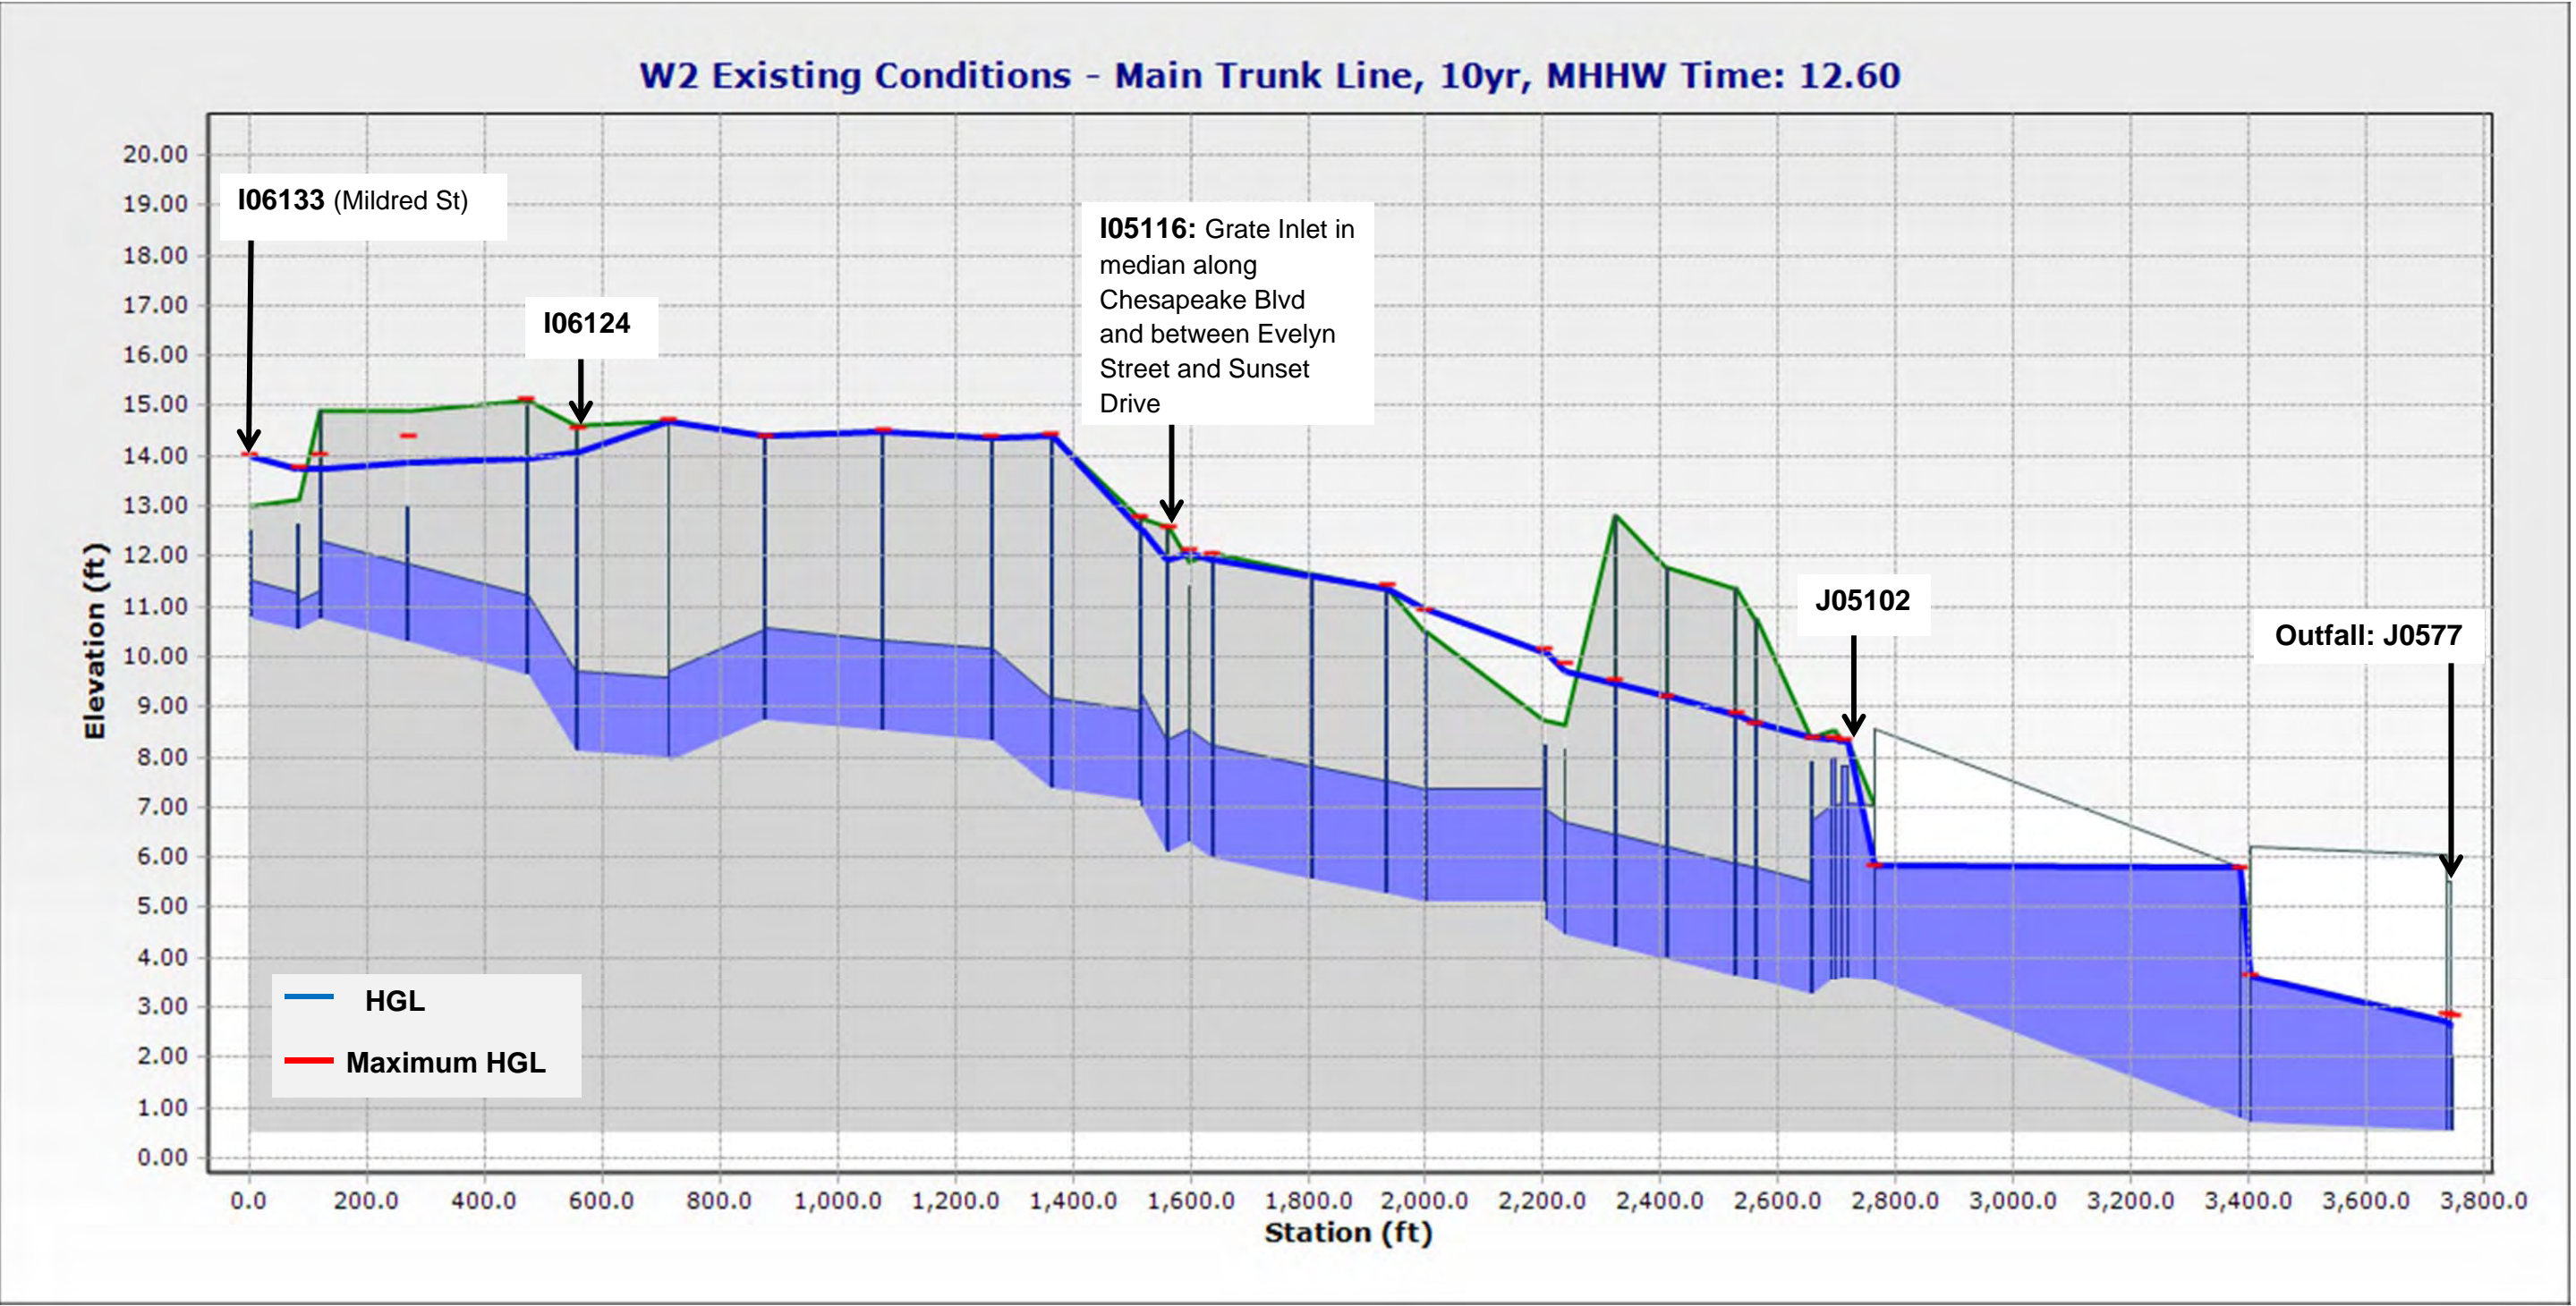
C.6. Sub-Watershed 2 - Existing Conditions along Main Trunk Line

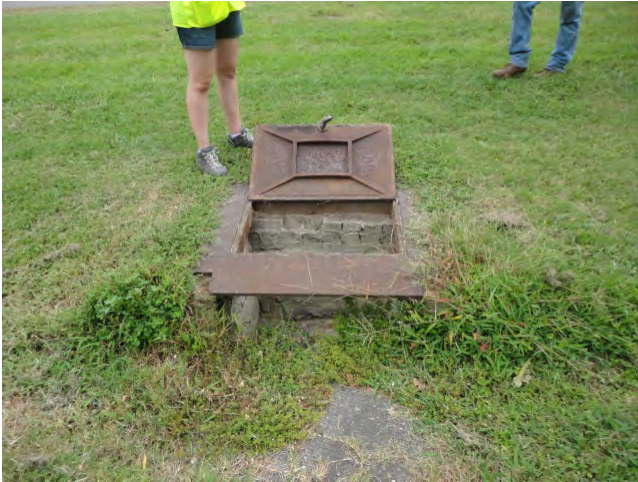
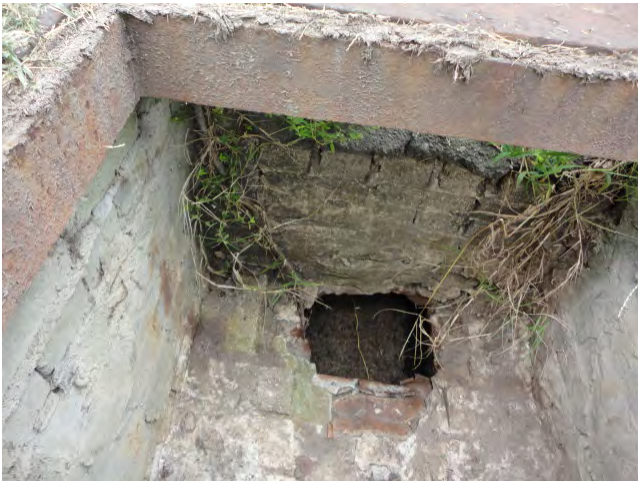
Structure Number **I061015**

Notes: pipes squashed

Condition G(**P**oor , **F**air , **G**ood , **A**waiting Install , **R**emoved from Service)

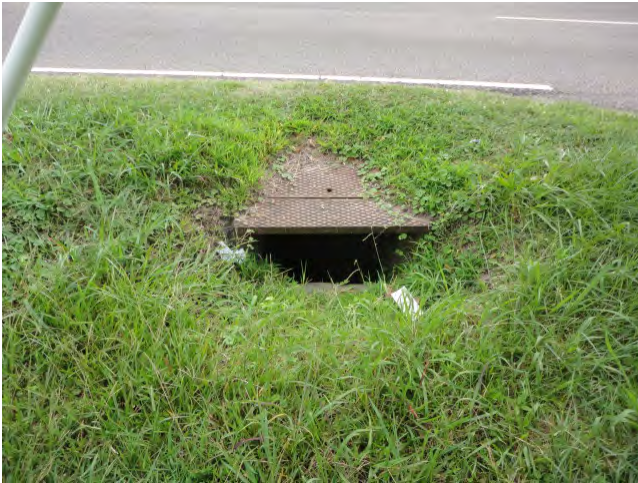
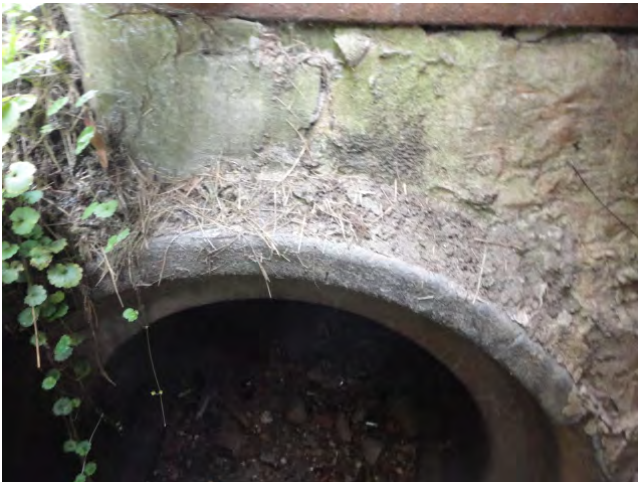
Structure Number **I061027**

Notes: large opening; fairly vegetated

Condition G(**P**oor , **F**air , **G**ood , **A**waiting Install , **R**emoved from Service)

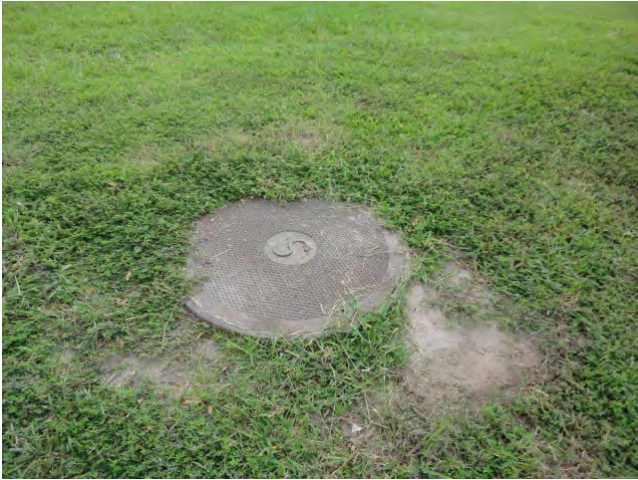
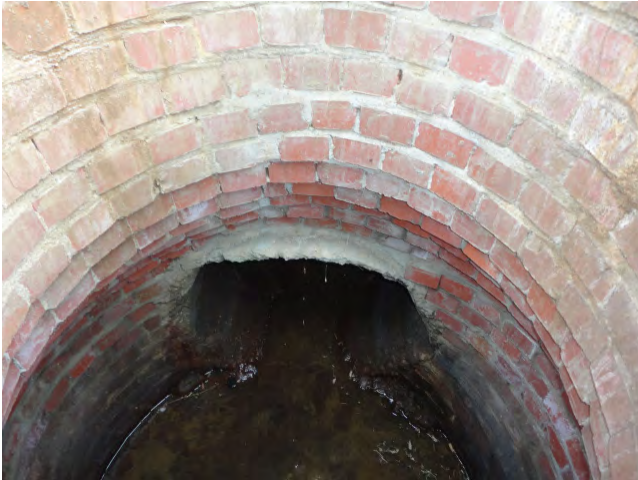
Structure Number **I061030**

Notes: water in structure

Condition G(**P**oor , **F**air , **G**ood , **A**waiting Install , **R**emoved from Service)

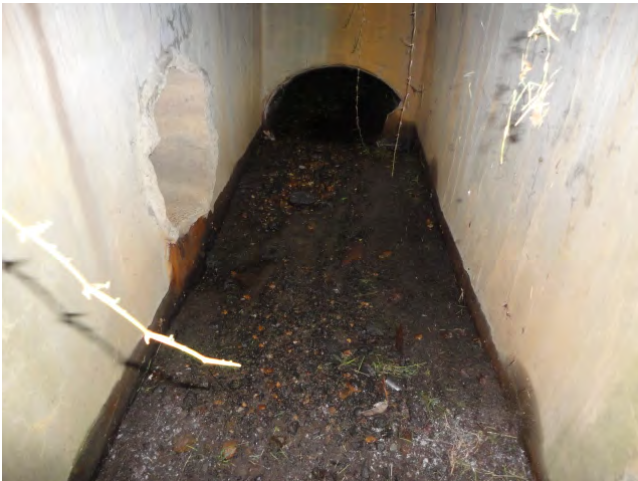
Pic 2 (inside structure w/ pipe out @ 12 o'clock)

Notes: 8' is length of structure - two grates
